**DOT HS 808 300**

October 1993

# Final Report of a 1992 Dodge Ram B250 Van Rear Impact CNG Fuel Tank Integrity

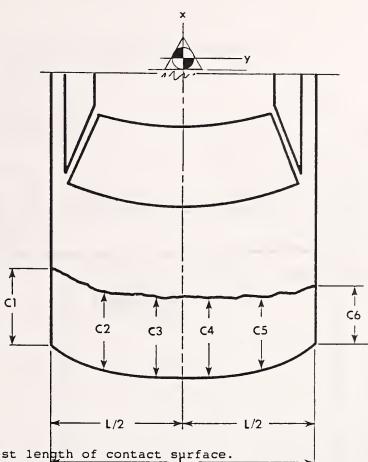
#### FIGURE 2 VEHICLE CRUSH

TOTAL CRUSH: L 5.7; C 5.8; R 5.4

AVERAGE CRUSH: 5.6

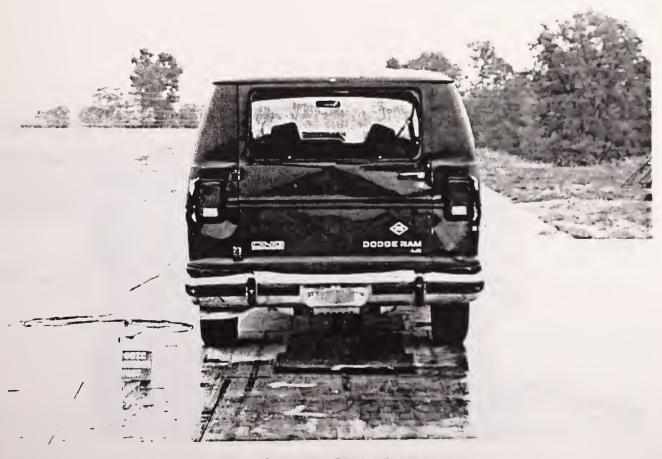
Figure A-6. POST-TEST REAR VIEW

DRIVER	PASSENGER
HEAD	AN	NA
CHEST	АИ	NA
ABDOMEN	AN	NA
LEFT KNEE	АИ	NA
RIGHT KNEE	АИ	NA
DOOR OPENING:		
	LEFT	RIGHT
FRONT	Opened easily	Opened easily
REAR	АИ	Opened easily
SEAT MOVEMENT:		
	SEAT BACK FAILURE	SEAT SHIFT
FRONT	Both back seats failed	No
REAR	No	Мо
GLAZING DAMAGE:	The rear window and two side w	vindows broke during
	the crash.	
OTHER NOTABLE IMPA	CT EFFECTS:	
	None	
	,,one

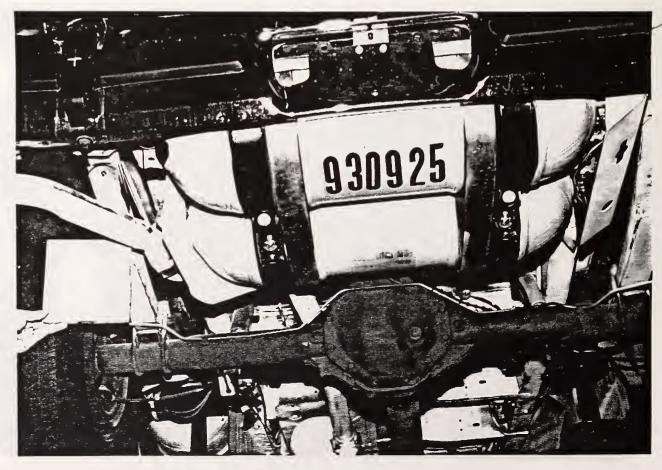
Figure A-20. POST-TEST FUEL TANK VIEW

The test vehicle, a 1992 Dodge Ram B250 van, appeared to comply with the proposed performance requirements of FMVSS 303 in the rear moving barrier impact mode. No gas appeared to leak from the vehicle's fuel system following the impact.
